Florida Seawall Repair by Slab Fix, LLC

Central Florida

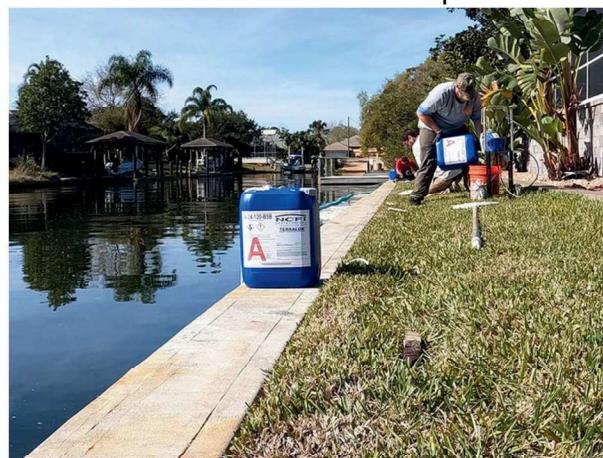
Tidal fluctuation was causing soil erosion underneath and behind the seawall. The problem signs came in the form of cracking and sinkholes forming along the wall. It was at a boat tradeshow where the homeowner identified a cost-effective repair solution with Slab Fix, LLC out of Orlando, FL. The issue at hand was severe: water was seeping underneath the spillway, saturating the soil beneath, and continuously filling a nearby creek, which should have remained dry except during heavy rains.

Slab Fix approached the project by probing the soil along the entire 360ft, 6ft tall seawall to identify the weak soil zones. When a weak soil zone was found, Slab Fix would flag the location for treatment. After testing the soil density and identifying the void locations, Slab Fix was ready to repair the wall using the NCFI-120 (formerly Terra-Lok™ 24-120) polyurethane.

Using a 6ft injection rod, Slab Fix injected the NCFI-120 at every weak soil point location. The 6ft rods allowed them to inject the NCFI-120 at the base of the seawall, and, once the injections started, the installer would pull the rod to the surface to allow the polyurethane to permeate the entire zone from bottom to top.
