King Mesa Gin's Solution to Water Intrusion

Lamesa, Tx

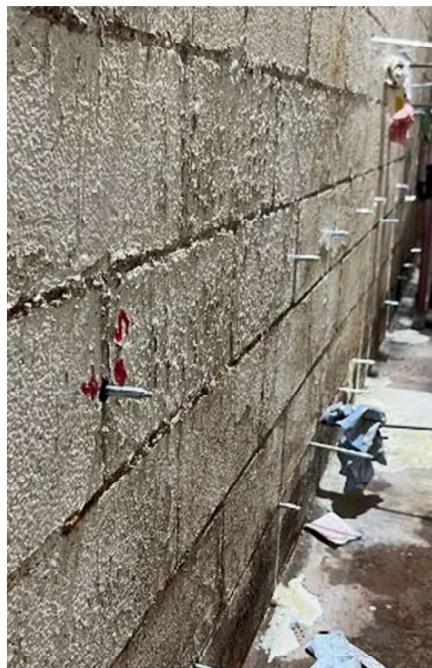
Problem

King Mesa Gin in Lamesa, Texas, faced significant water intrusion in the basement's "press pit," threatening the safety of its personnel and the integrity of its equipment and products.

King Mesa Gin enlisted WTX Foundation Repair from Amarillo, Texas, and Earth Contact Products from Olathe, Kansas, to tackle the problem. After evaluating the damage caused by fluctuating water levels over the years, the teams chose the NCFI-120 Single Component polyurethane (formerly Terra-Lok™ 120) for the job. This solution involved injecting over 400 gallons of NCFI-120 to form a monolithic waterproof barrier along the walls of the press pit. Although initial plans included sealing the floor, unforeseen complexities with the double-slab concrete structure shifted the focus only to the walls in the project's first phase. The discovery of further seepage led to a second phase where the team sealed gaps between the floor slabs to fully prevent water infiltration.
