Concrete Uprising Stabilizes Inundated Elevator Pit

Chapel Hill, NC

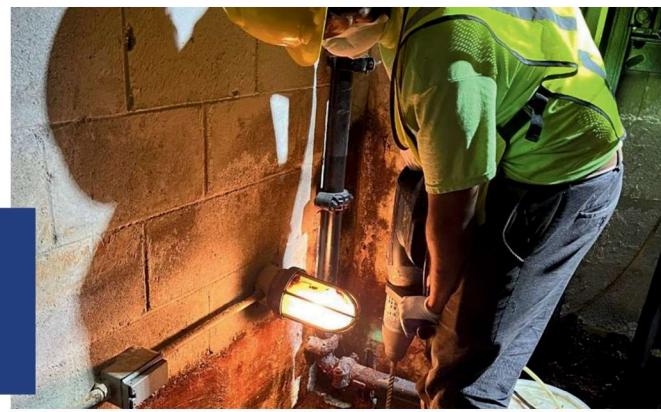
The elevator pit presented a daunting challenge as it was inundated with an astonishing 4 to 5 feet of water. This excessive water accumulation not only jeopardized the structural integrity of the elevator shaft but also led to the development of mold on the bottom floor due to the excessive moisture. Concrete Uprising swiftly identified the problem and embarked on a comprehensive approach to stabilize the pit.

Understanding the urgency of the situation, Concrete Uprising initiated the stabilization process by promptly dewatering the elevator shaft. Recognizing the magnitude of the water ingress, the company had to utilize two pumps to effectively remove the substantial volume of water from the pit. By meticulously dewatering the shaft, the team created a conducive environment for the subsequent stabilization measures.
