Florida Seawall Repair by Slab Fix, LLC

Central Florida

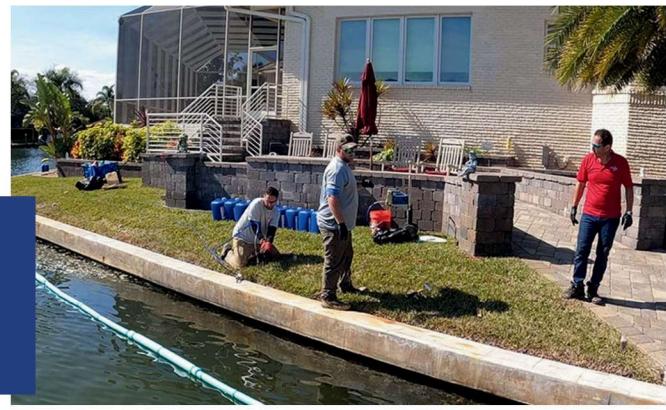
Continuous tidal fluctuations, soil erosion, and relentlessly pounding waves cause seawalls to deteriorate and the soil to become weak and voids to form. This was the experience a homeowner was going through with their Central Florida coastal home, necessitating seawall repair.

Tidal fluctuation was causing soil erosion underneath and behind the seawall. The problem signs came in the form of cracking and sinkholes forming along the wall. It was at a boat tradeshow where the homeowner identified a cost-effective repair solution with Slab Fix, LLC out of Orlando, FL. The issue at hand was severe: water was seeping underneath the spillway, saturating the soil beneath, and continuously filling a nearby creek, which should have remained dry except during heavy rains.

Slab Fix approached the project by probing the soil along the entire 360ft, 6ft tall seawall to identify the weak soil zones. When a weak soil zone was found, Slab Fix would flag the location for treatment. After testing the soil density and identifying the void locations, Slab Fix was ready to repair the wall using the NCFI-120 (formerly Terra-Lok™ 24-120) polyurethane.

Using a 6ft injection rod, Slab Fix injected the NCFI-120 at every weak soil point location. The 6ft rods allowed them to inject the NCFI-120 at the base of the seawall, and, once the injections started, the installer would pull the rod to the surface to allow the polyurethane to permeate the entire zone from bottom to top.
