NJTA Culvert Rehabilitation

Woodbridge, NJ

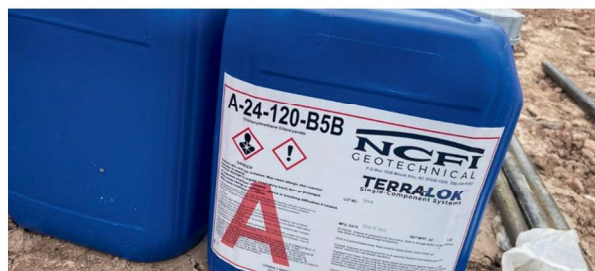
ECRR took soil samples onsite to confirm the moisture content for determining the NCFI-120's chemical reaction. ECRR then approached the project by injecting the NCFI-120 on a 2ft grid pattern at 8ft depths. As the culvert was 25ft below the surface, the injection pattern allowed for excellent soil permeation at optimal depth to stabilize the culvert, roadway, and the soil in between.

After a 3-day installation, polymer travel was confirmed through visual observation in the culvert, confirming full material penetration. The polymer sealed cracks and walls around the culvert perimeter.
